Device TC1797
Marking/Step QS-AC
Package P/PG-BGA-416-10

01961AERRA

This Errata Sheet describes the deviations from the current user documentation.

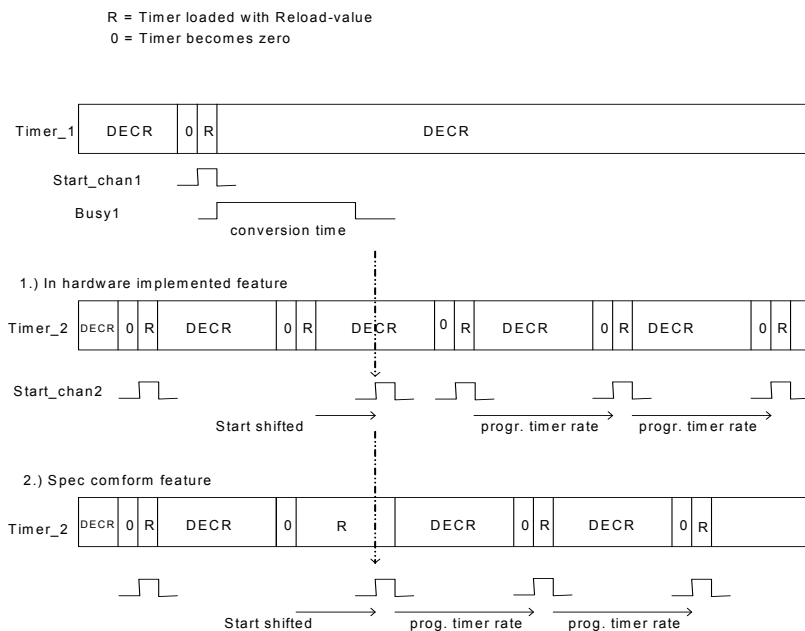
Figure 1 Timing concerning equidistant multiple timers

The correct behavior would be a reload when the requested conversion (of channel_2) is started.

Therefore the start of conversion for channel_2 is delayed by maximum one conversion-time. After this delay it will be continued with equidistant conversion-starts. Please refer to the following figure.

Note: the programmed timer rate is much longer than the conversion time, this means that the fault is much smaller than in the picture

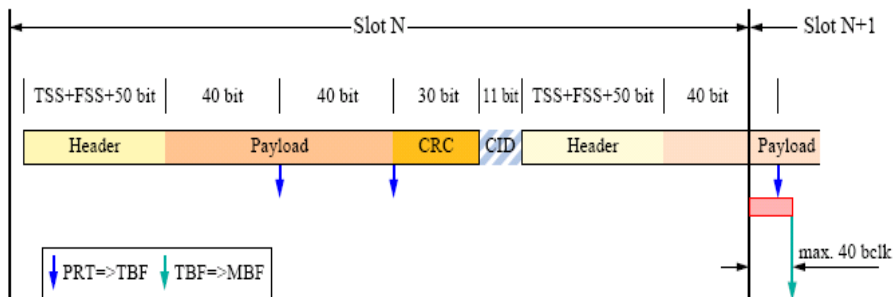
Figure 2 The second frame starts in the same slot

The erratum is limited to cases where the complete header and a part of the payload of another frame is received in slot N.

The transfer of a received valid frame from TBF to MBF is initiated by the end of the actual slot. Execution is started not later than 40 bclk periods after the slot change. 40 bclk periods equate 10 bit times, when $\text{bclk}=40\text{MHz}$. Corruption of payload occurs when a transfer from PRT to TBF happens in the red marked time window between start of new slot and start of transfer from TBF to MBF.

1. Ensure that the static slot length is configured suited to the static payload length.
2. Check Message Buffer Status for boundary violation.

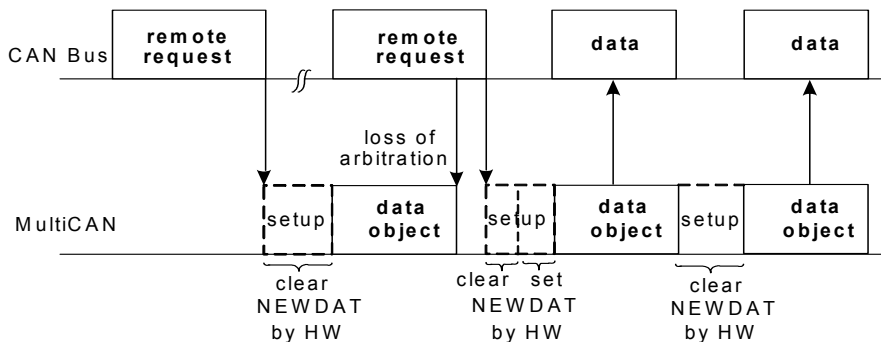
Figure 3 Loss of Arbitration

When the appropriate message object (data frame) triggered by the first remote frame wins the arbitration, it will be sent out and `NEWDAT` is not reset. This leads to an additional data frame, that will be sent by this message object (clearing `NEWDAT`).

There will, however, not be more data frames than there are corresponding remote requests.
