SX127x Development Kit

# Troubleshooting Guide

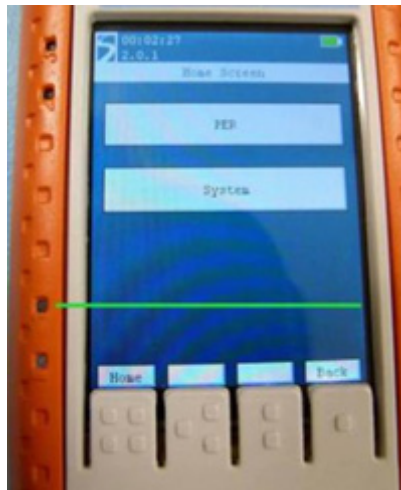
If the part number of the SX127xRF1xAS module configured in the EEPROM (Target device) is not correct, take the Eiger platform configured with the SX127xDVK1xAS PER firmware **V2.1.0-RC** or later version and plug the SX127xRF1xAS module on the kit.

You can re-program the EEPROM by clicking on the virtual green line, at the same level as the LED on the left, from the Home menu.

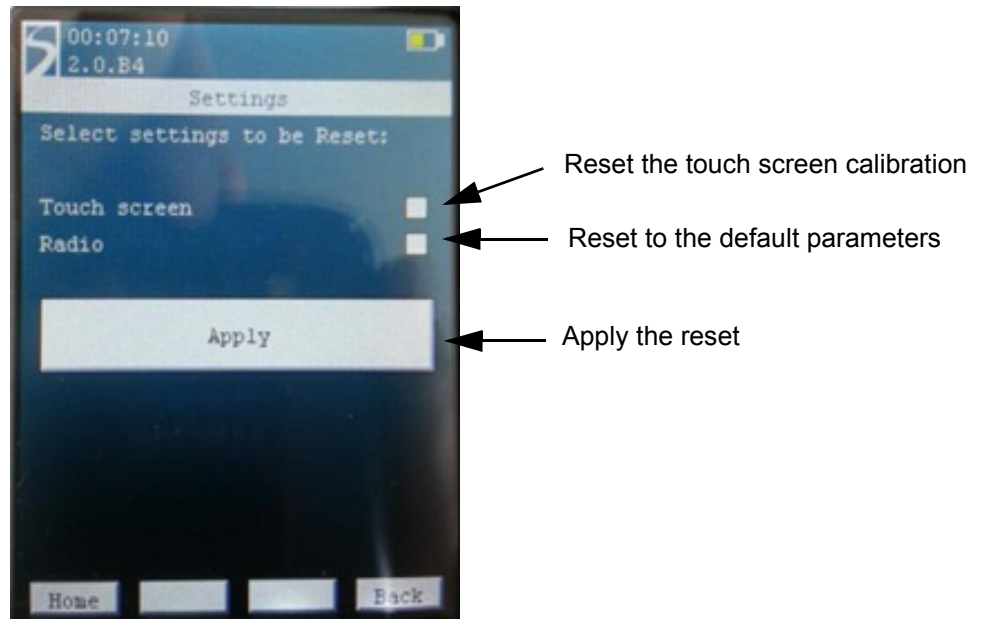
Use this procedure if the touch screen is not accurate but still usable. You can perform simple re-calibration by clicking on menu -> System -> Settings -> Touch screen (select) -> Apply

Perform a new calibration of the touch screen on each cross with the stylus provided. Wait 10sec to record parameters in the EEPROM when the procedure is finished.
