Intel[®] Ethernet Controller E810

Specification Update

March 2023

Revision 3.2
616943-013

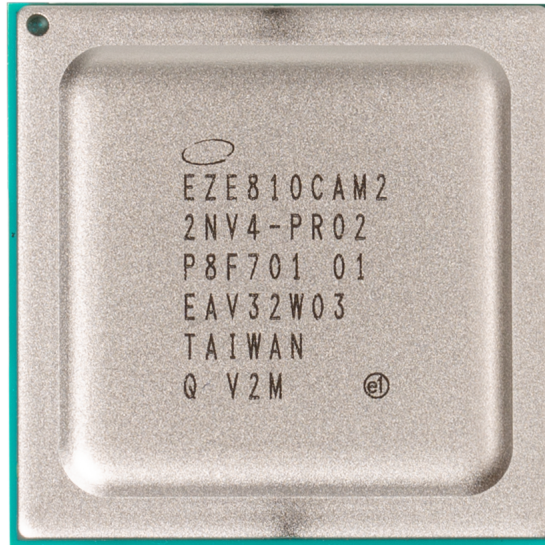
Figure 1-1. Example Component with Identifying Marks
