# Intel® Ethernet Controller X710-TM4/AT2 and V710-AT2

**Specification Update**

Revision 1.9  
615119-011

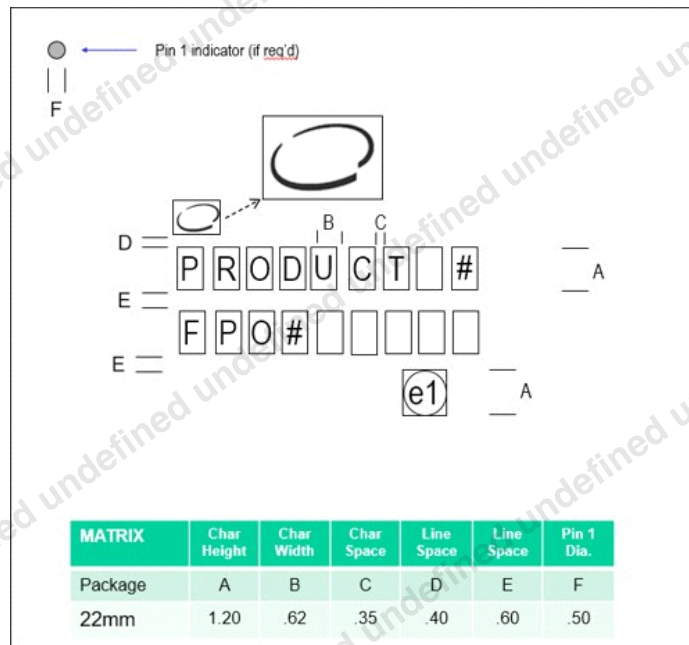
Figure 1-2. Marking Diagram

- LINE1: Swirl Logo.
- LINE2: Product Number. For example, EZX710TM4.
- LINE3: Lot Trace Code. For example, T641AS01.
- LINE4: Pb Free Symbol.
