Intel[®] Ethernet Controller X710-TM4/AT2 and V710-AT2

Specification Update

March 2023

Revision 2.3
615119-015

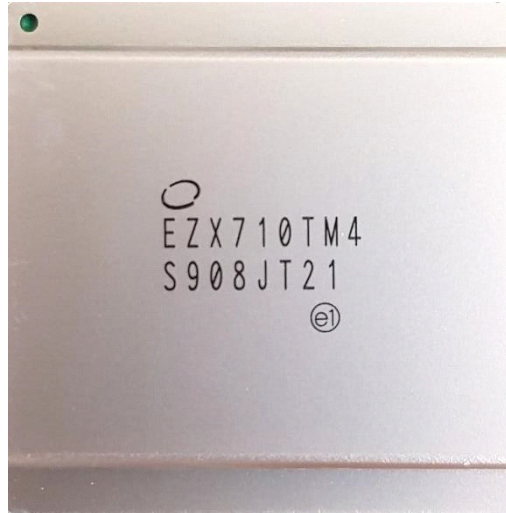
Figure 1-1. Example Component with Identifying Marks
